Winnicut River Dam Removal Monitoring Plan

New Hampshire Department of Environmental Services
NH Coastal Program
222 International Drive, Suite 175
Portsmouth, NH 03801

New Hampshire Fish and Game Department
225 Main St.
Durham, NH 03824

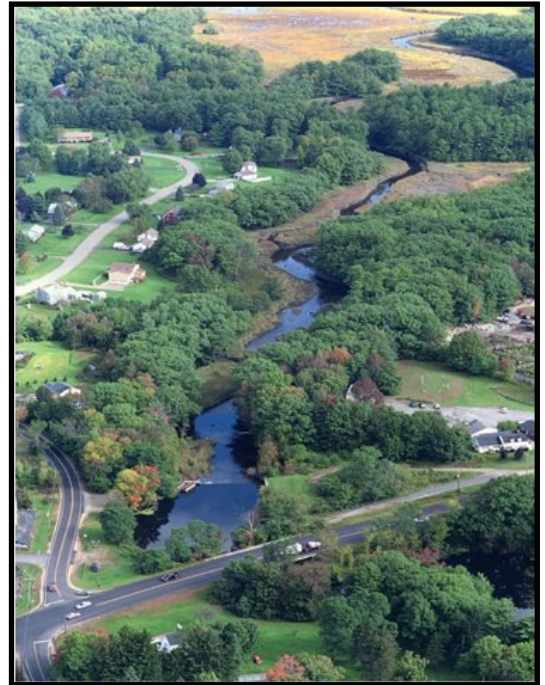
Figure 1. Water velocities (on left) beneath Route 33 are too swift for river herring to pass as indicated by the red as opposed to the slower water velocities indicated in blue. The pool-and-weir fish pass (on the right) will be installed underneath the Route 33 Bridge.

A feasibility study completed in 2006 revealed that the Route 33 crossing over the Winnicut River (immediately upstream of the dam) severely narrowed the channel cross section. The study indicated that a velocity fish passage barrier would be created beneath Rt. 33 if the dam were removed. The NHFGD decided to remove the Winnicut River Dam and adjoining Canadian step-weir fish ladder and construct a 132 ft long x 20 ft wide pool-and-weir, run-of river, cast-in-place concrete fishpass beneath the Route-33 Bridge. The new fish pass will maintain the water elevation within the impoundment upstream of Route 33; however, at approximately 18 inches below conditions that existed with the dam in place.

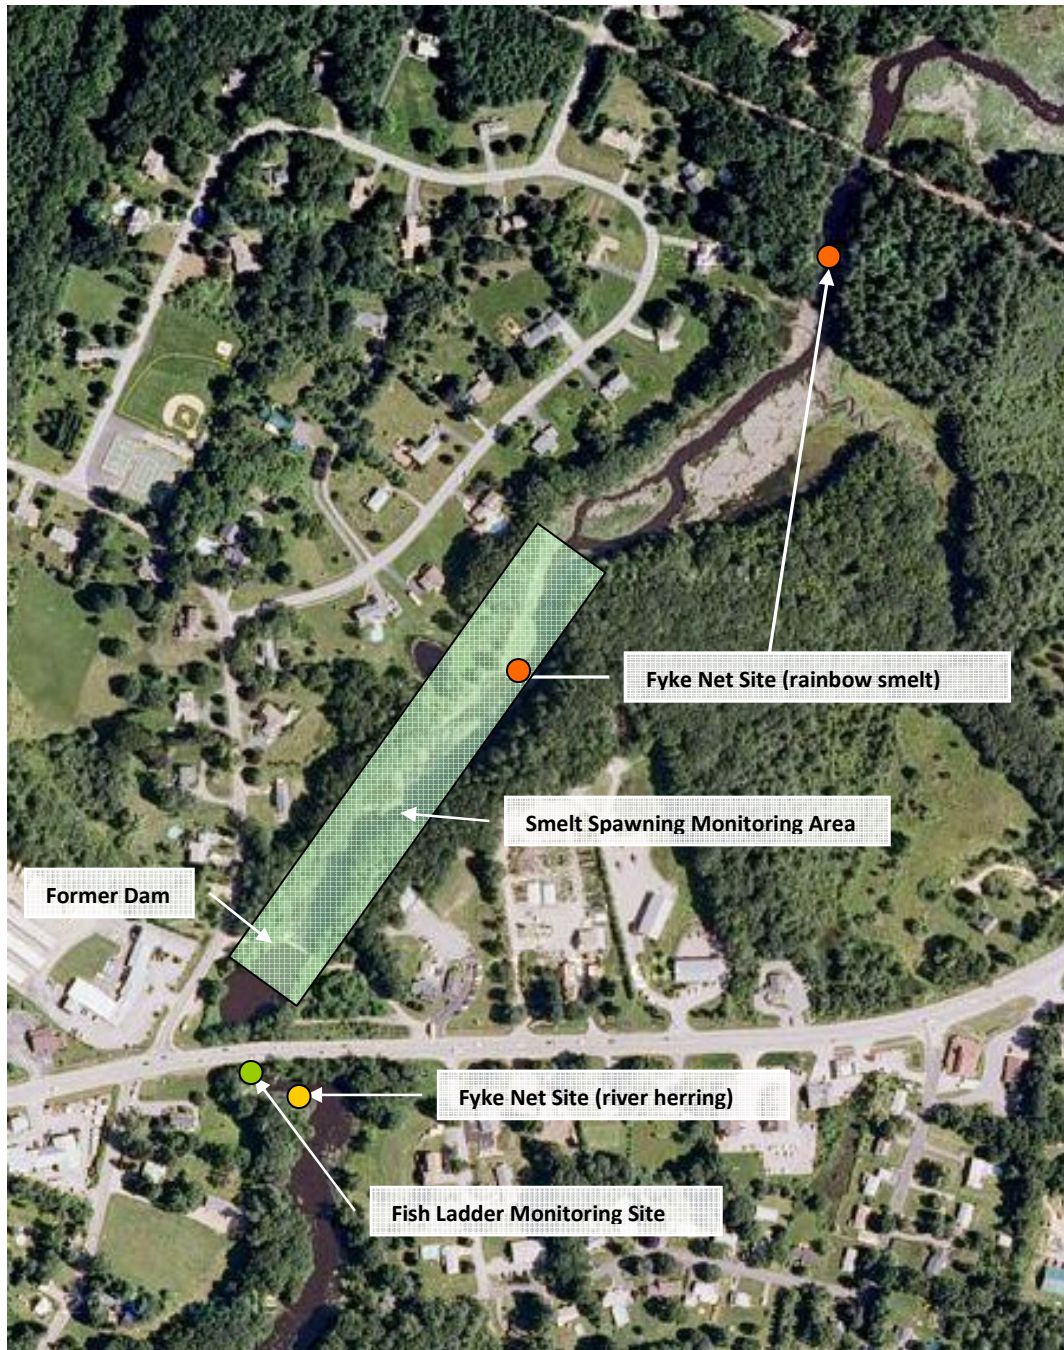
Figure 2. Winnicut River Dam Removal Project - river herring and rainbow smelt monitoring sites.

The fish counting method selected would be deployed from approximately April 15th through July 1st in years 1, 3, and 5 after installation of the fishpass. A minimum of one visit per day by at least one person during the river herring migration would be required to perform time counts, calibration counts, or net checks. The date and time of counts will be recorded so data can be expanded or for an electronic device, checked for accuracy. While on site, condition of batteries in equipment will be checked, any accumulated debris from viewing area or entrances to counting tube(s) can be cleared, and proper functionality of the counting equipment can be assessed. In addition, the recording equipment will need to be housed in a secure container to prevent damage from weather or vandals. See Figure 2 for monitoring sites.

With the Winnicut Dam removed, the former impoundment between the former dam site and the NH Rt. 33 overpass is anticipated to be quality smelt spawning habitat. Previously monitored habitat and the recently restored spawning areas will be checked annually for the next 5 years for the presence of rainbow smelt spawning activity (eggs present). A random sampling technique utilizing a ring of known diameter will be used to assess the utilization and extent of available spawning habitat that is being used and compared to a data time series initiated in 1979. The habitat will be visited once each week at low tide during spring spawning months (approximately March through May), a ring will be randomly tossed 40 times onto spawning substrate, and eggs within the ring will be counted. An estimated total number of eggs per square foot will be calculated for all available spawning habitat within the Winnicut River. Twenty random egg counts will occur below the former dam in previous sampled habitat (and comparable to previous sampling area and technique) and 20 random counts above the former dam in new substrate (Figure 2).

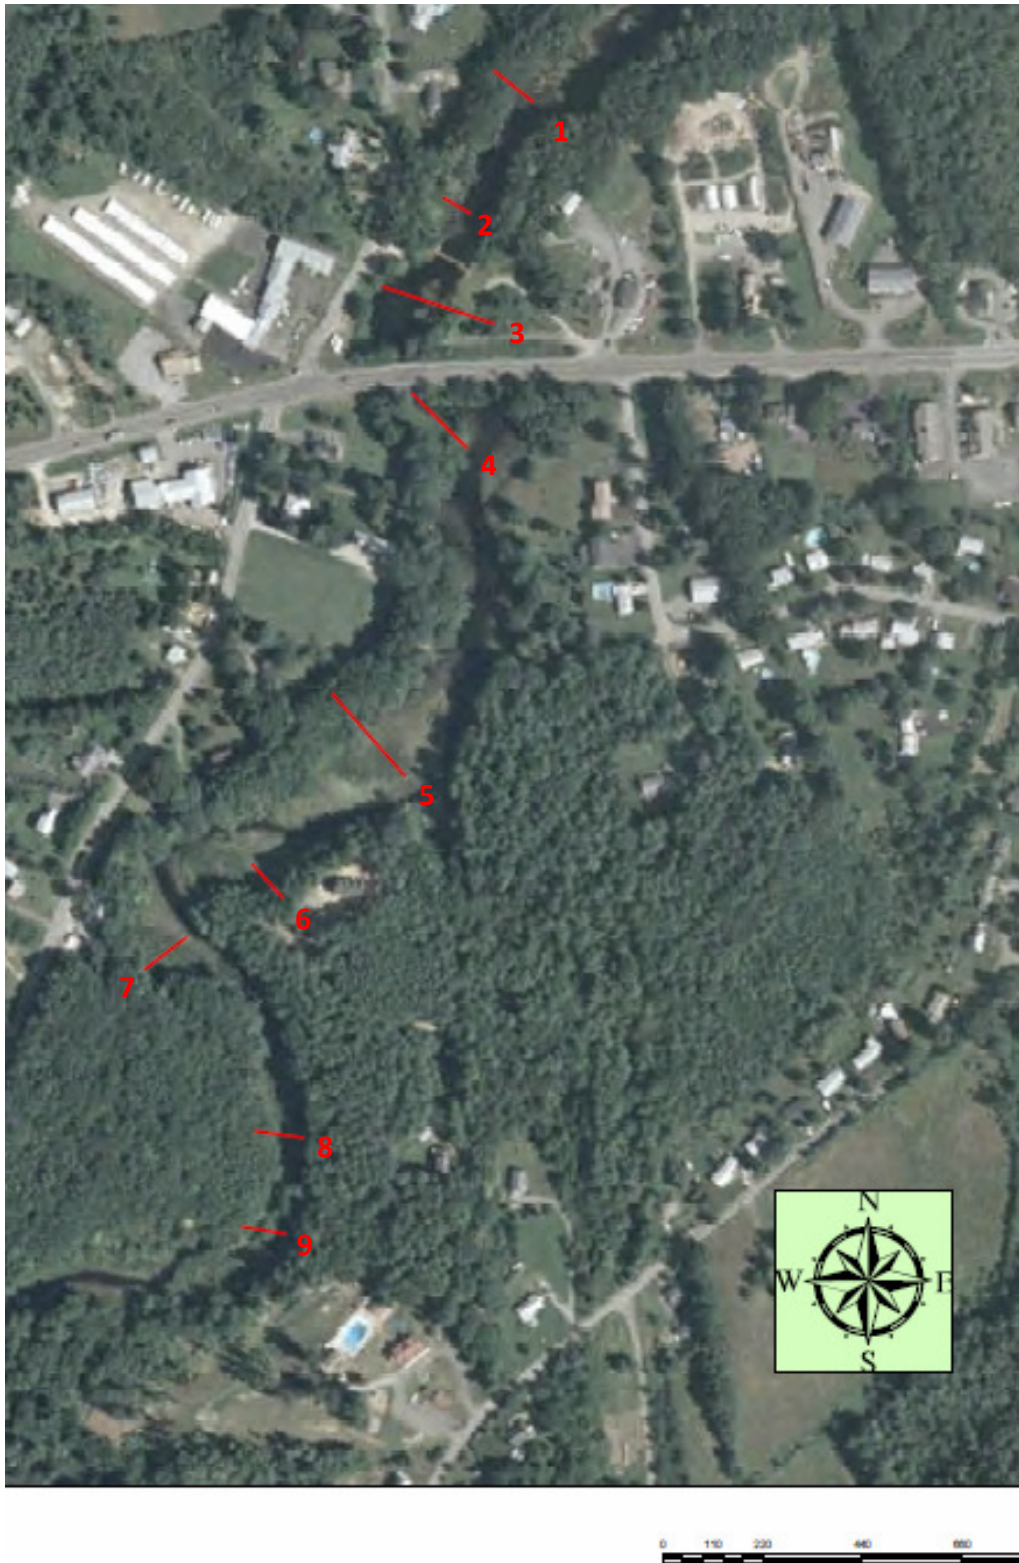
Figure 3. Transects established for photo-documentation and to characterize changes in vegetation.

The transect start and end points were geo-referenced by GPS to allow reproducibility of monitoring efforts in subsequent years (Table 3). In addition, transect endpoints were described in the field notes and marked with flagging. A total of 9 transects were established, 7 of which are upstream of the dam site and 2 were established downstream of the dam (Figure 3).

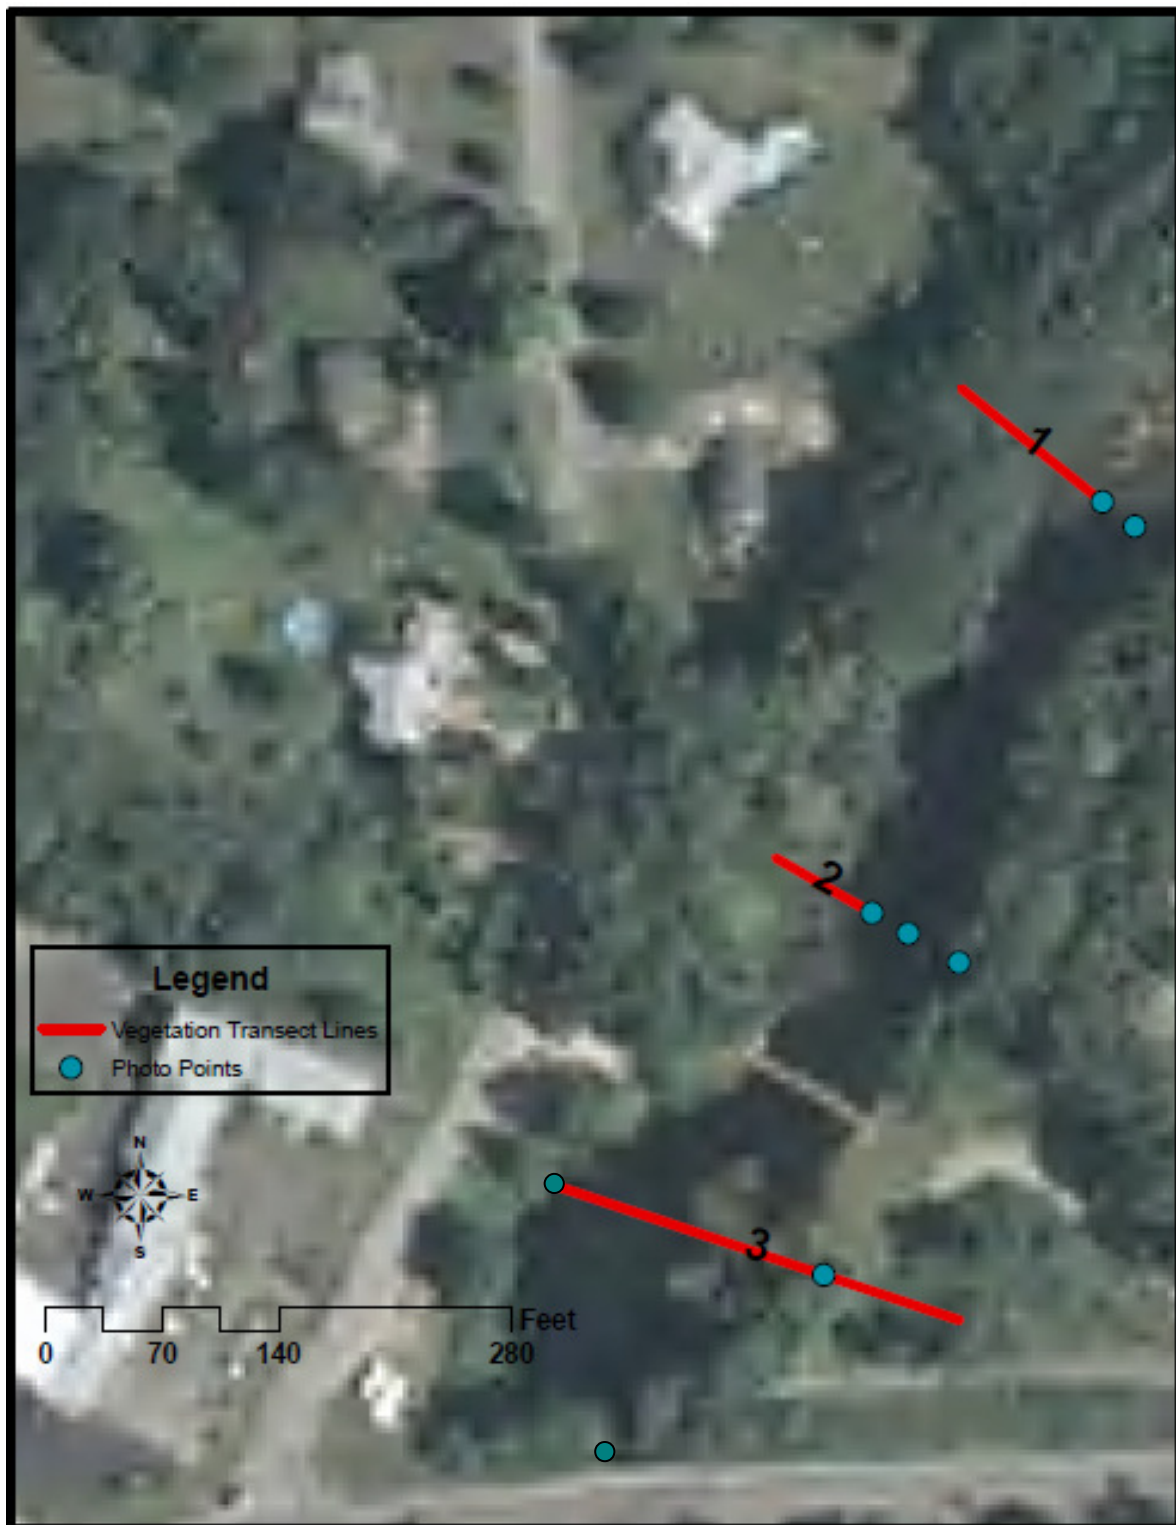
Figure 4. Photo Monitoring Points Winnicut River Downstream of Route 33

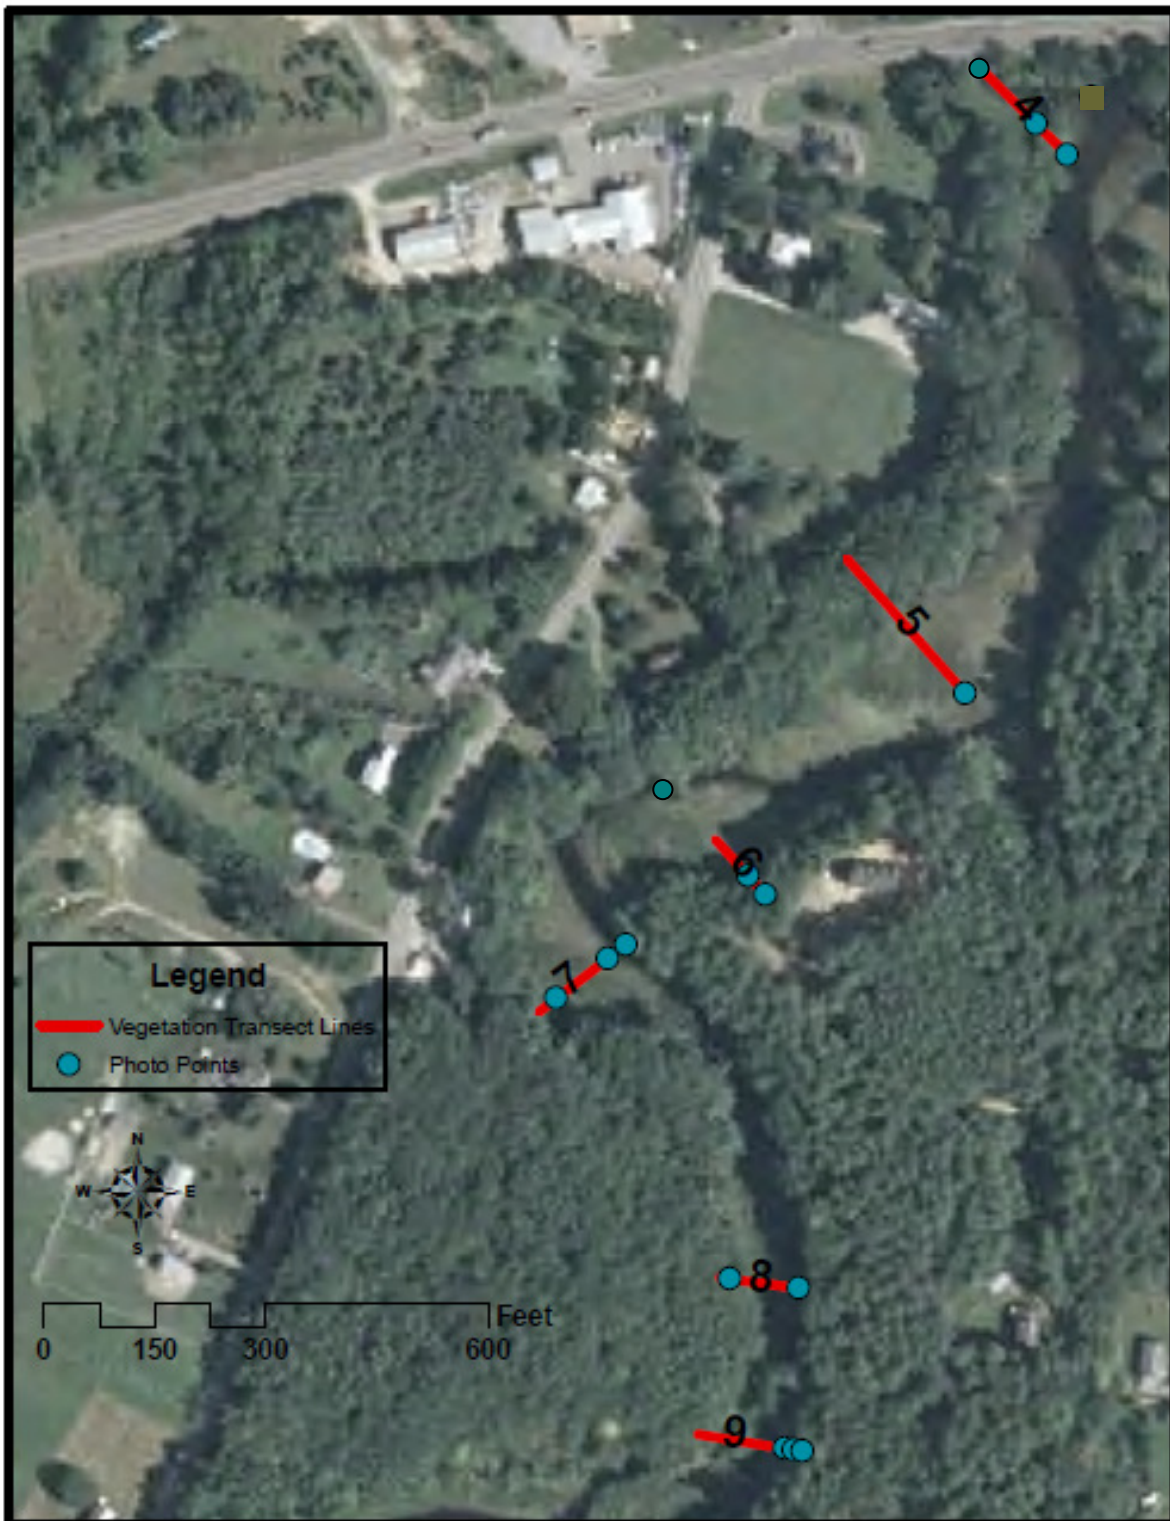
Figure 5. Photo Monitoring Points Winnicut River Upstream of Route 33

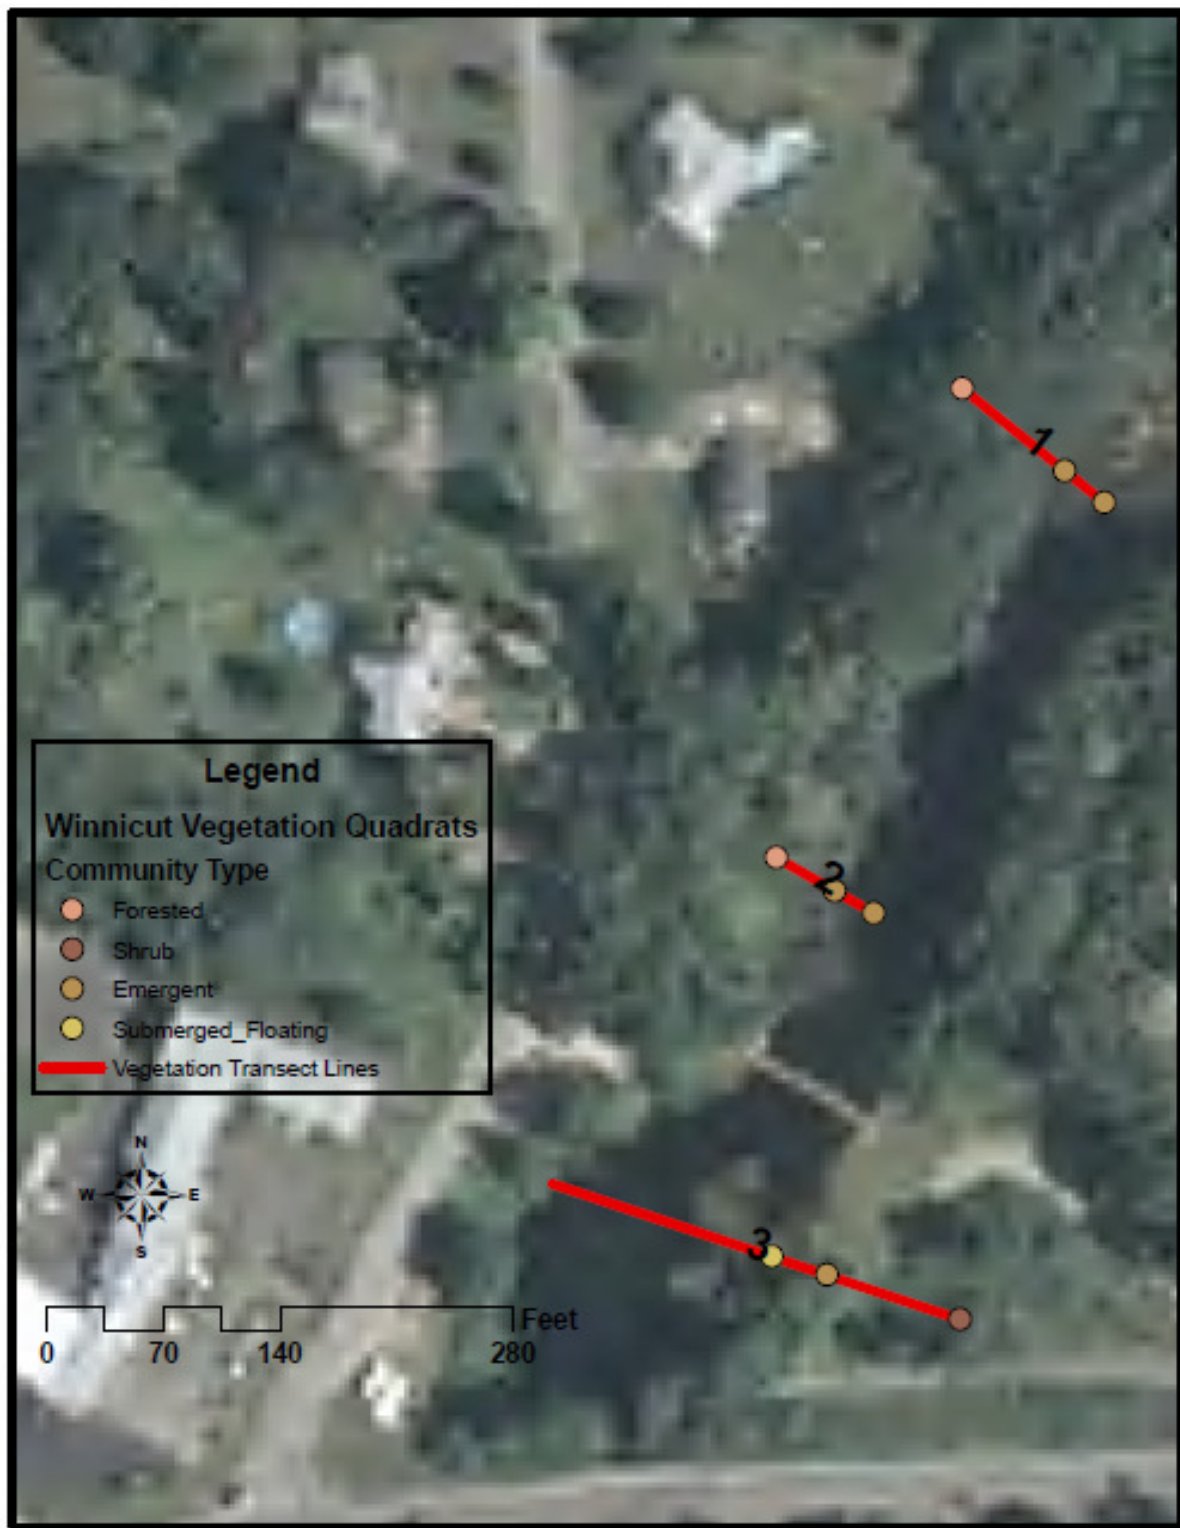
Figure 6. Winnicut Vegetation Transects and Plots -Downstream of Route 33.
